# Robotic plumber repairs pipes in nuclear power plants

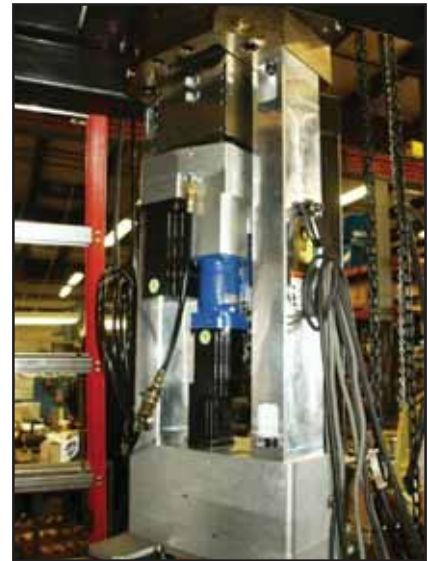
**Figure 1**

*The base of the CNC machine is located in the equipment area below the piping at the power plant.*

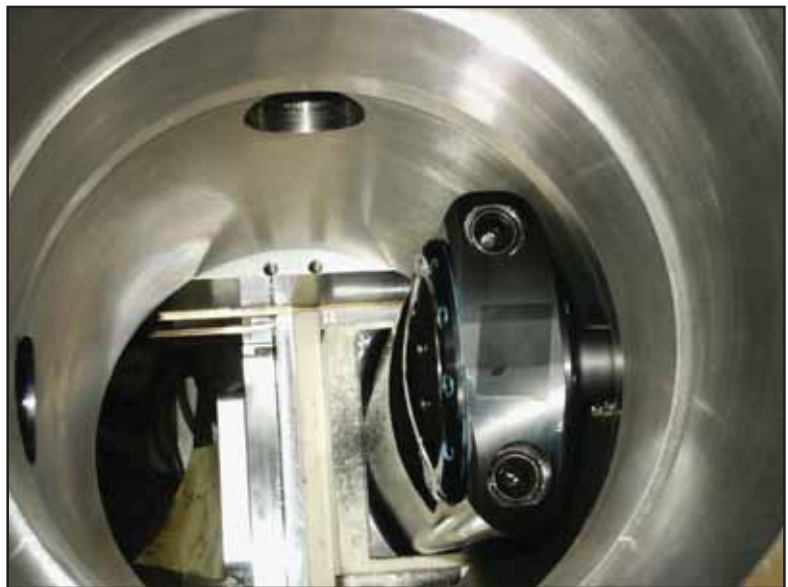
**Figure 2**

*The CNC tool spindle operates inside the pipe.*

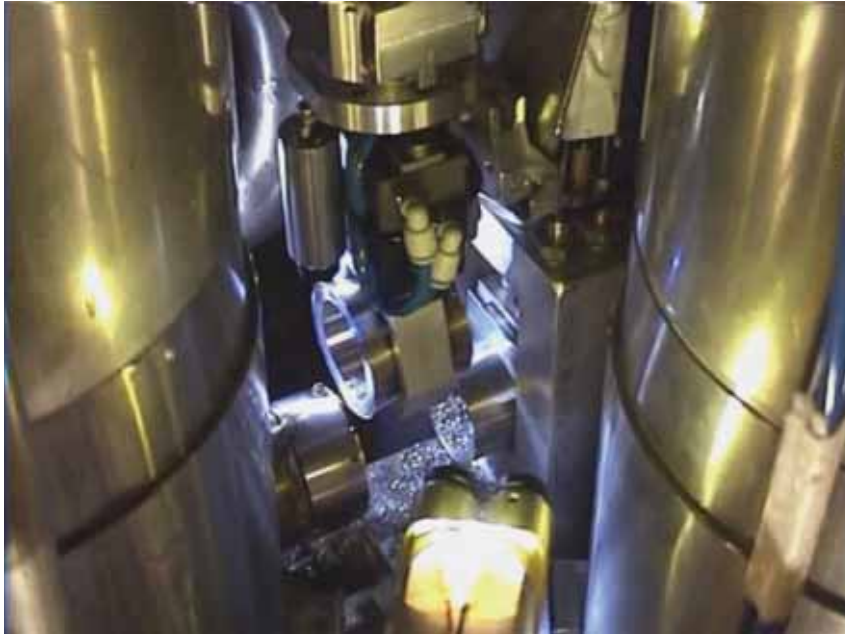
**Figure 3**

*The system's robotic arm removes a cut section of pipe.*
